# Transportation Project Report

## Draft Project Scoping Report/Final Design Report

Loft Rd over Schenevus Creek (BridgeNY 2021) Bridge Replacement  
Project Identification Number (PIN): 9755.19  
Bridge Identification Number (BIN): 2227620  
Town of Maryland  
Otsego County

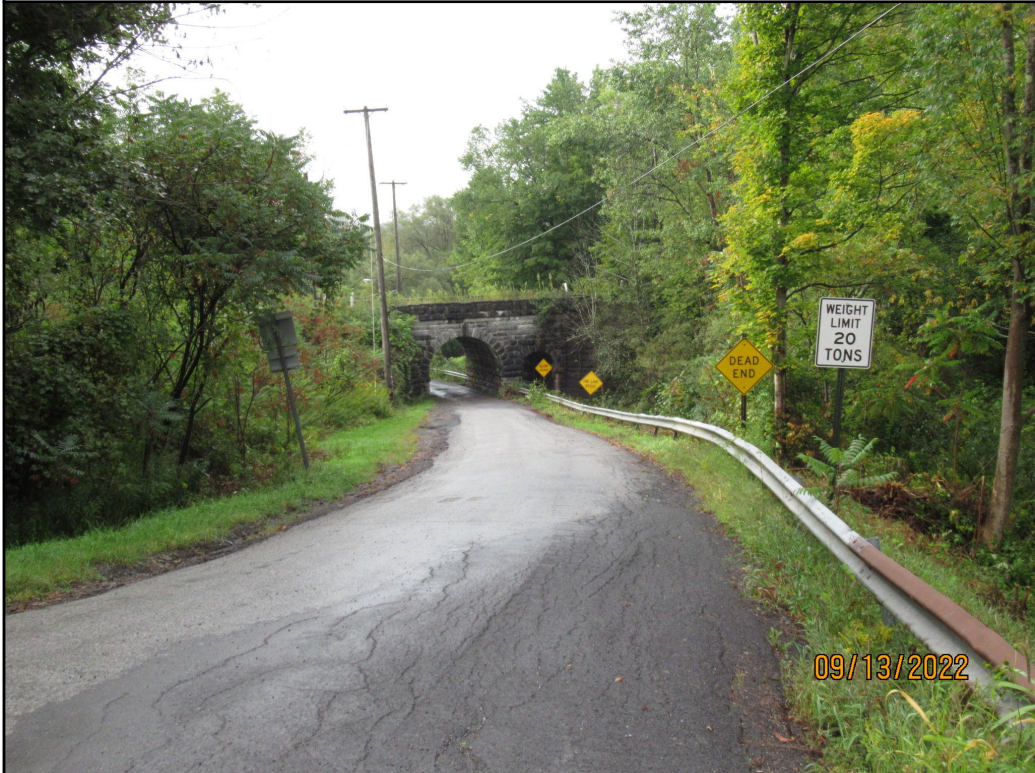
**Attachment Description:**  
End approach looking back

Vegetation has been cleared along the end approach, left side. All signs are clearly visible. Previous NSCO not reissued. See photo 1.  
Load posting signs at begin and end approaches are in good condition. See photo 1 and 2.

This is a steel, multi-girder bridge with a timber deck. The bridge is posted for 20 Tons based solely on a Level 2 Load Rating (Photos 1 and 2). There is no Level 1 Load Rating in the BIN folder or BDIS system. Therefore, the load posting is considered temporary/interim. Based on the 2021 Level 2 load rating, the bridge has an H20 inventory capacity of 17 tons and an operating capacity of 29 Tons. There are no lane restrictions across the bridge

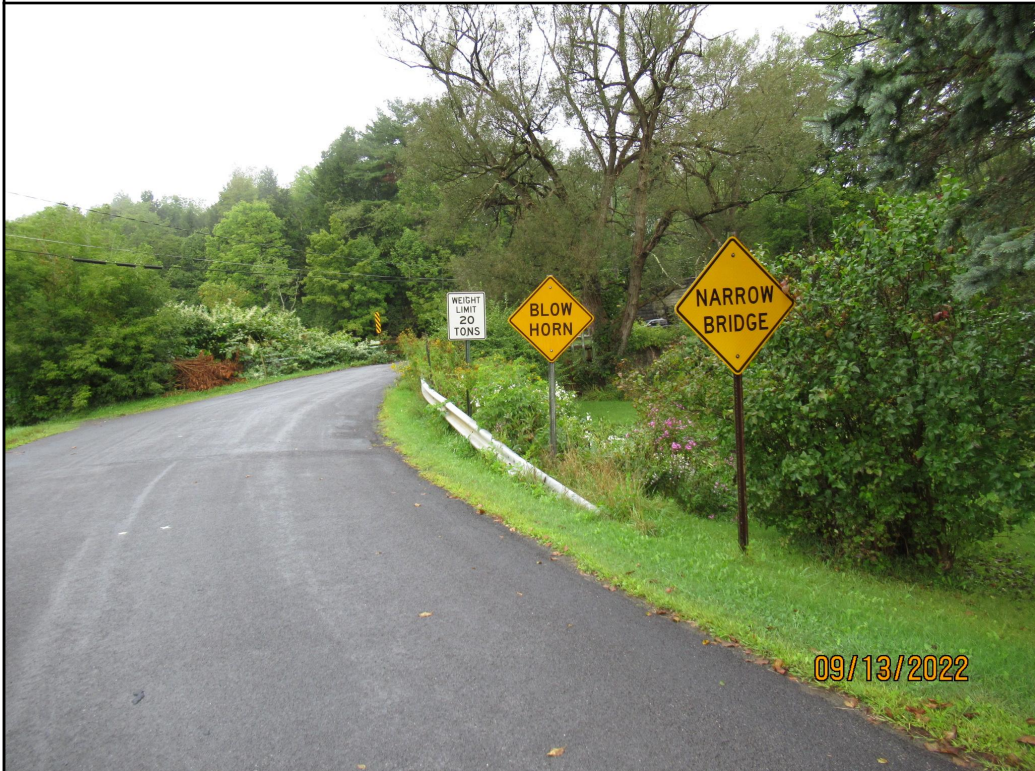
Photo Number: 2

**Attachment Description:**  
Begin approach looking ahead

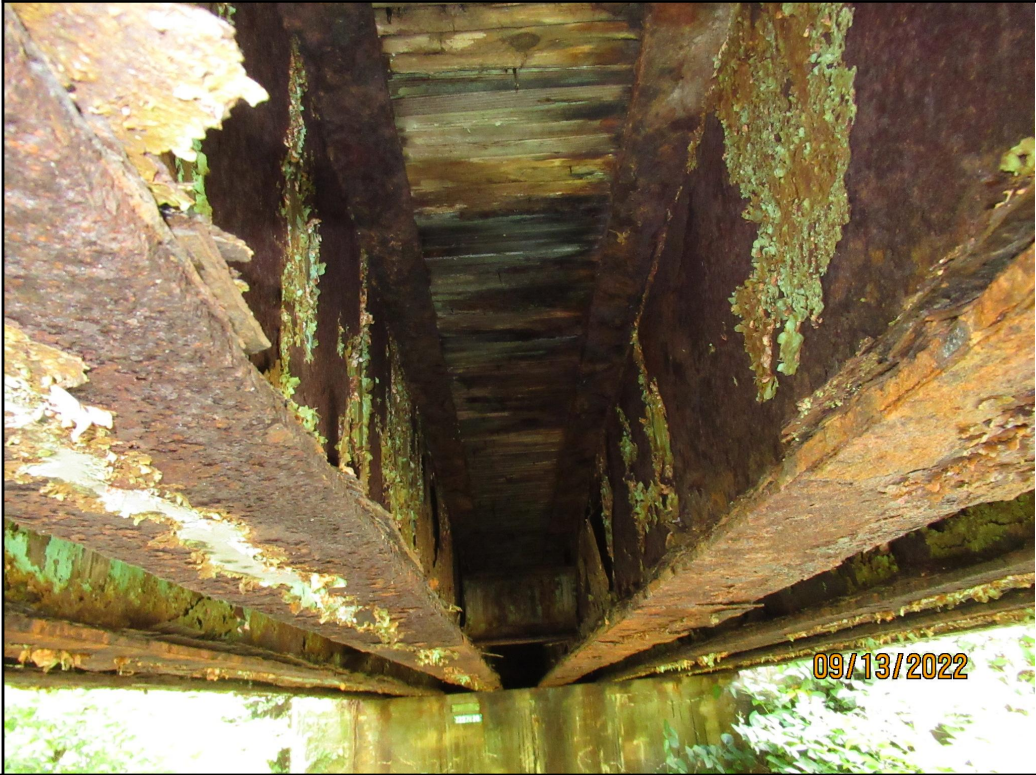
| <p><b>Attachment Description:</b><br/>Bay 4 looking back</p> | <div>Photo Number: 3      Photo Filename: 22_EH_0597.JPG</div> |

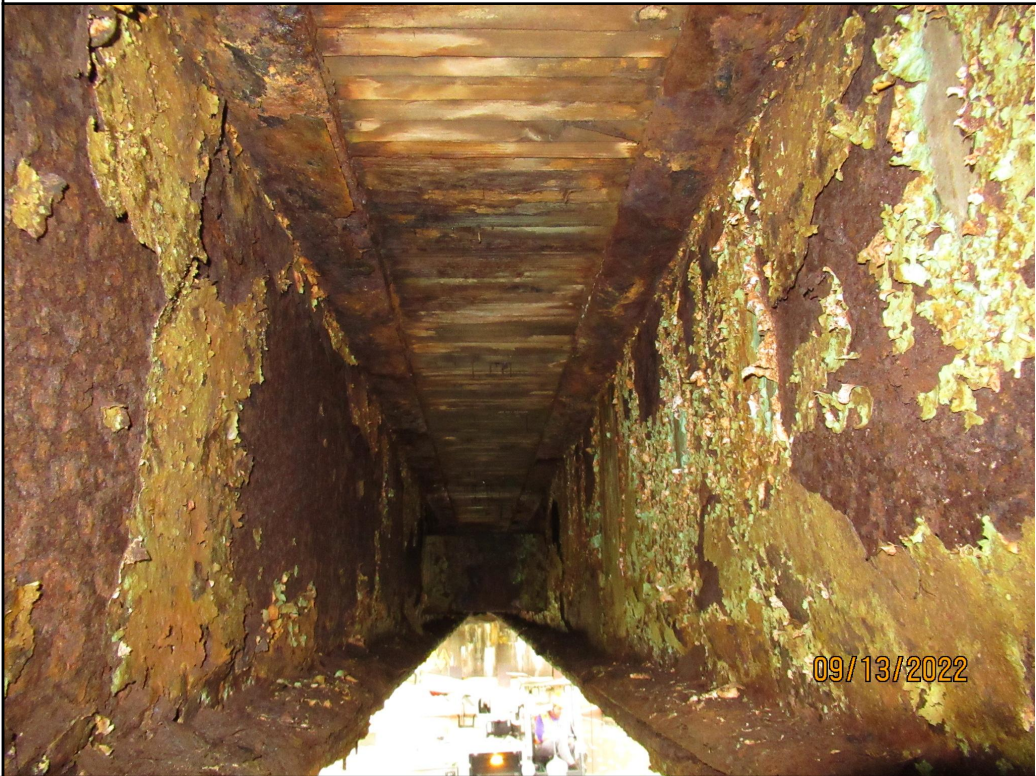
| <p><b>Attachment Description:</b><br/>Bay 4 looking ahead</p> | <div>Photo Number: 4      Photo Filename: 22_EH_0605.JPG</div> |

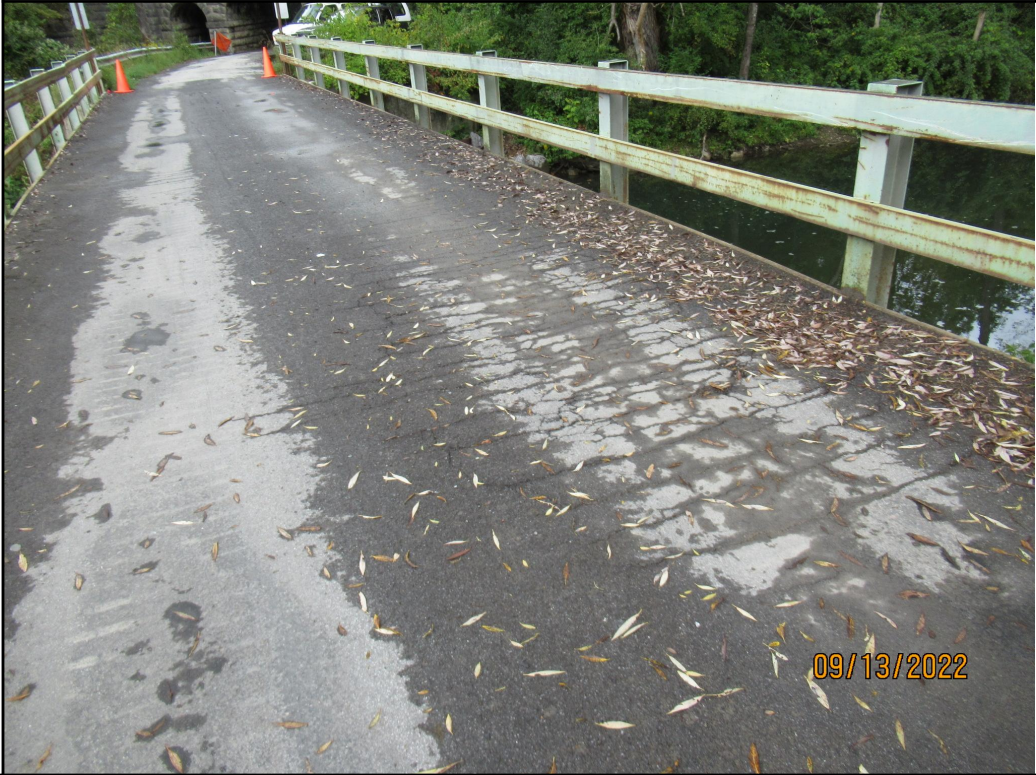
Photo Number: 5      Photo Filename: 22\_EH\_0602.JPG

**Attachment Description:**  
Begin right looking ahead

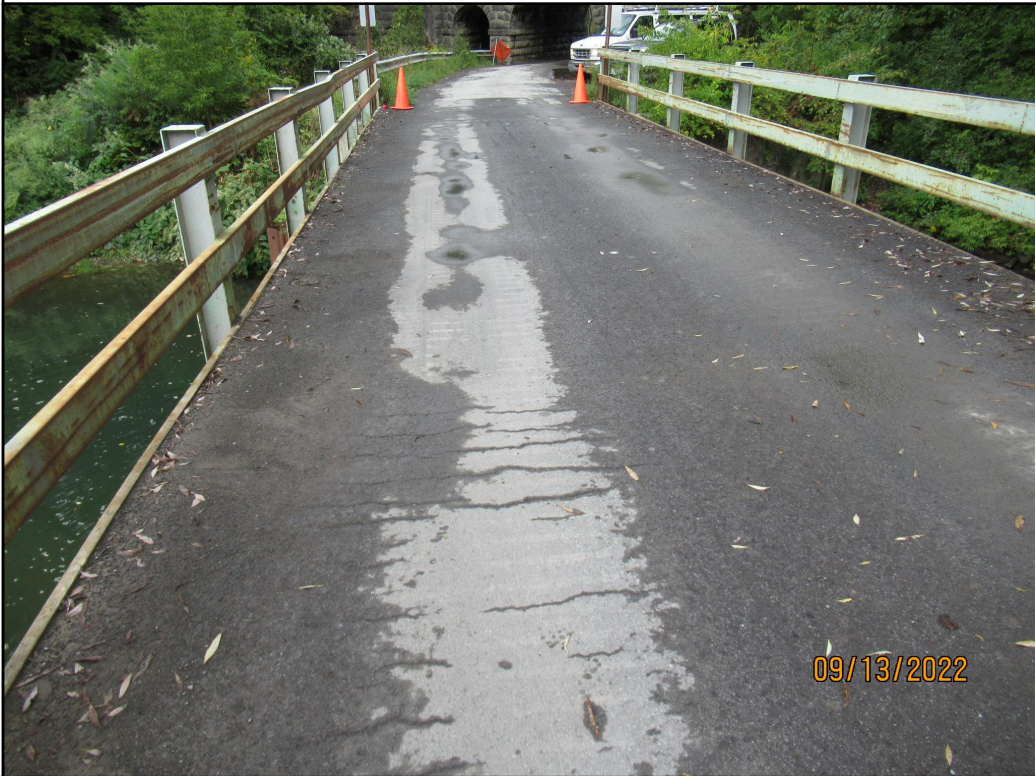
Photo Number: 6      Photo Filename: 22\_EH\_0603.JPG

**Attachment Description:**  
Begin left looking ahead

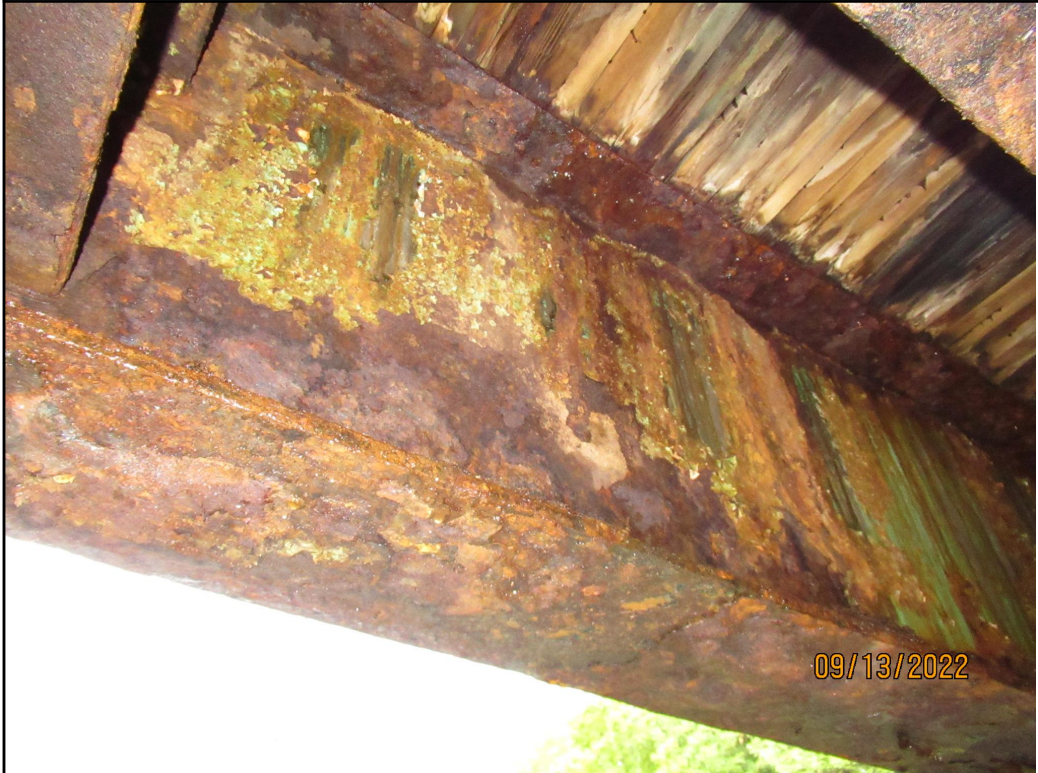
Photo Number: 7

**Attachment Description:**  
G1, midspan looking left

- a. Steel Girders – All girders exhibit section loss up to 15% at the bottom of the webs. The top flanges have minimum of 25% section loss, with the highest at girder 7 with 41%. The bottom flanges all exceed 15% with the highest at G3 with 42%
- b. Wearing Surface – The wearing surface is heavily cracked. By visual inspection, heavy leakage is observed in areas where the wearing surface is cracked. The surface is also uneven along the span as water pooling can be seen.
- c. Steel Protective Coating – The existing paint system has failed along all the girders.

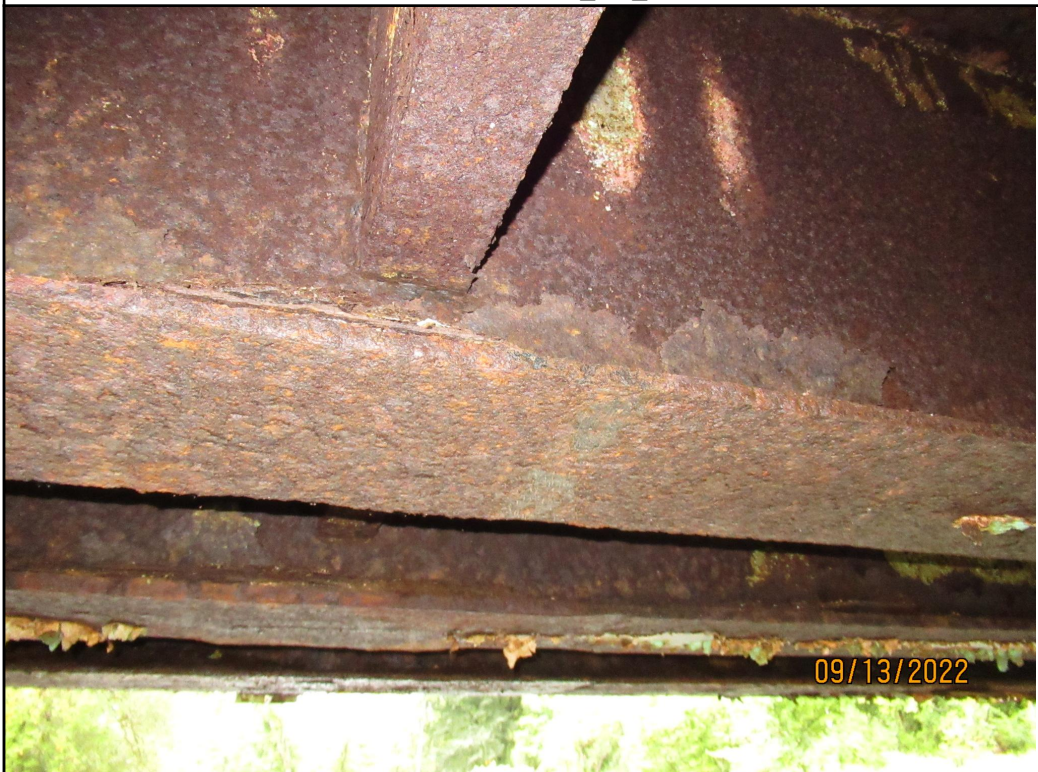
Photo Number: 8

**Attachment Description:**  
G3, midspan looking left

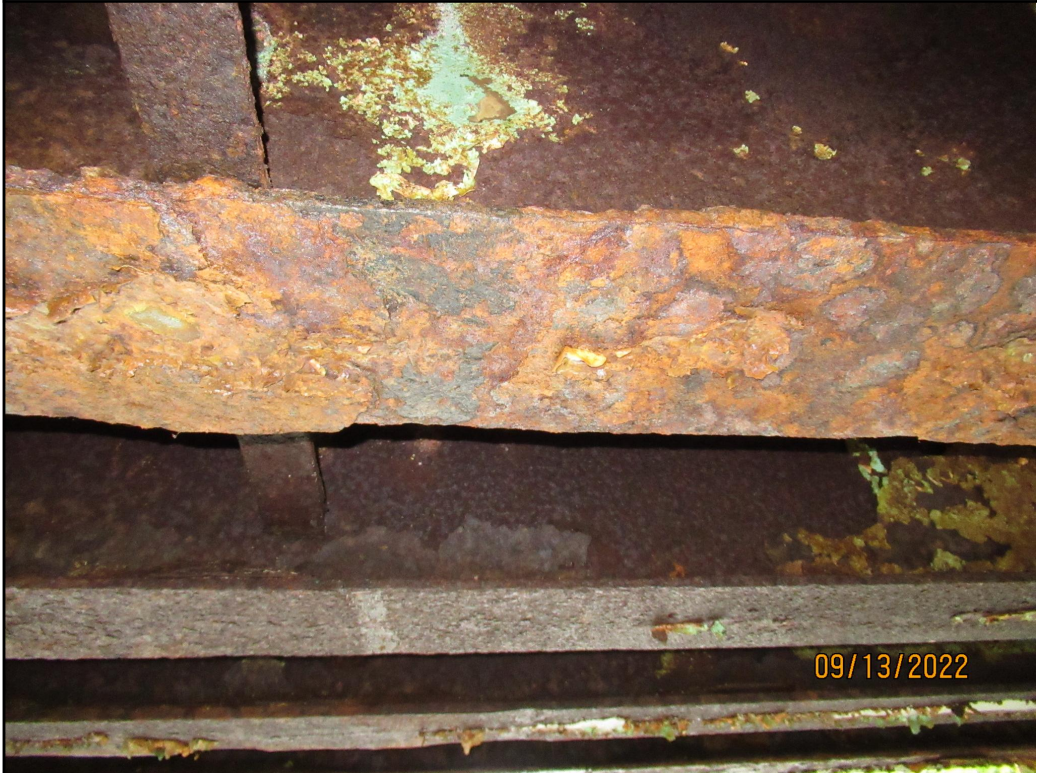
Photo Number: 9

**Attachment Description:**  
G4, midspan looking left

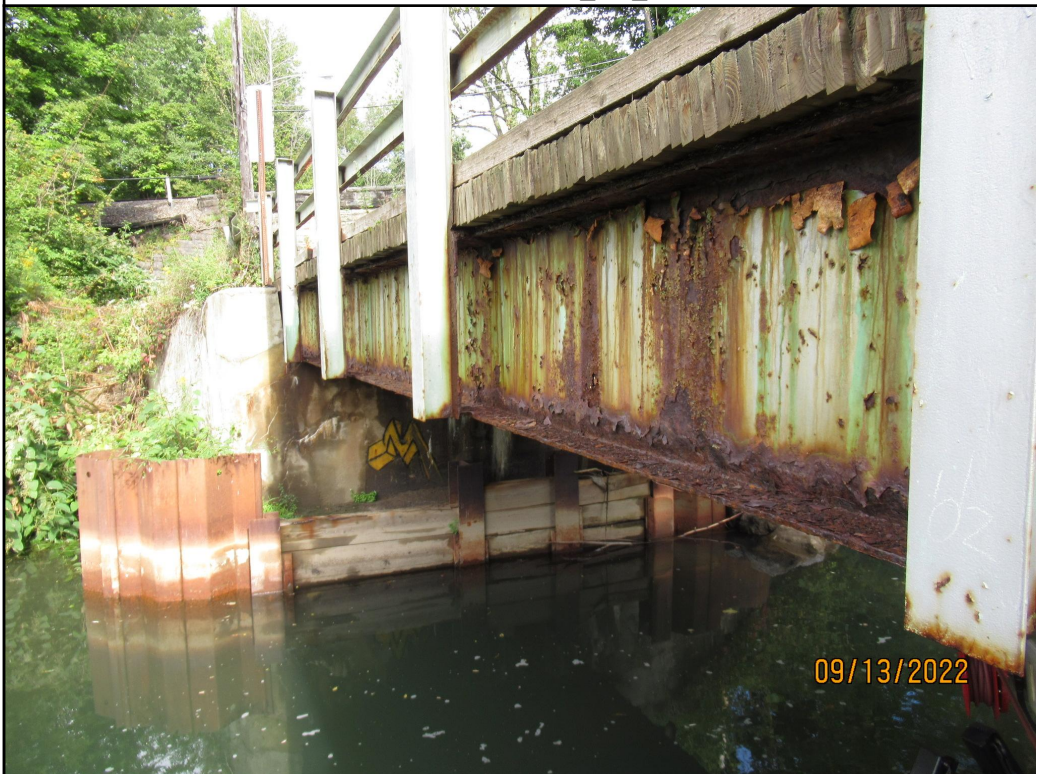
**Attachment Description:**  
G1, looking ahead from  
begin

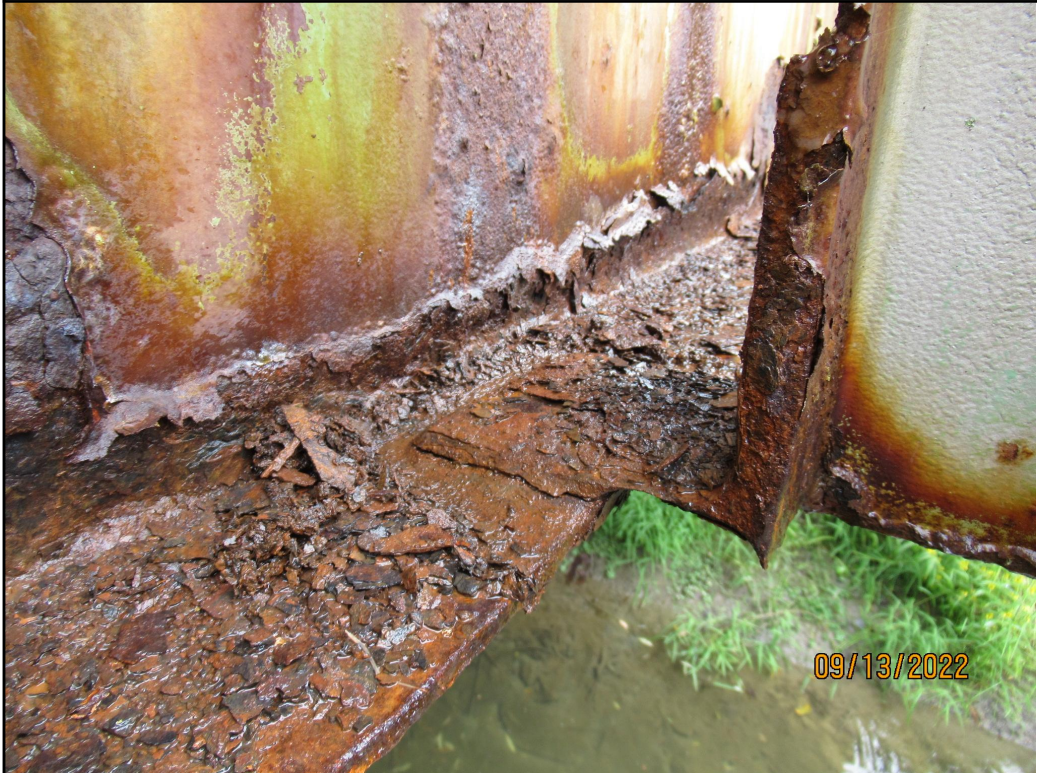
Photo Number: 11

**Attachment Description:**  
Post 4, left side looking  
back

Left side, post 4: The weld is cracked on the end side plus 50% of the back side. (photo 2)

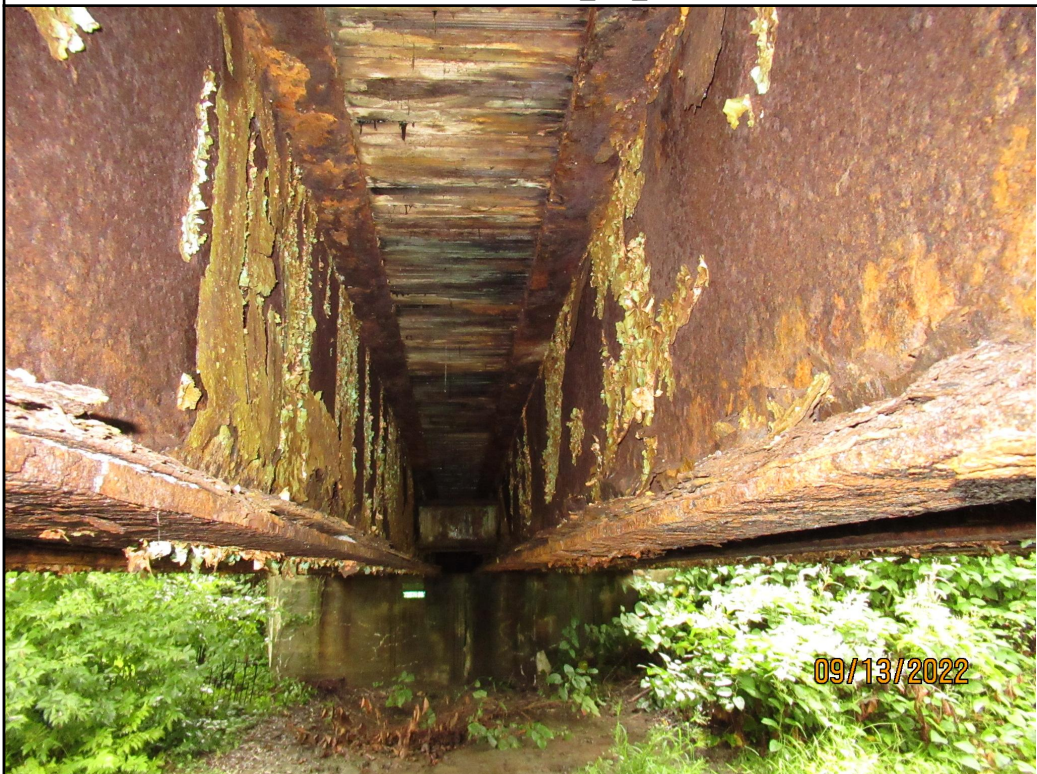
Photo Number: 12

**Attachment Description:**  
Bay 3, looking back

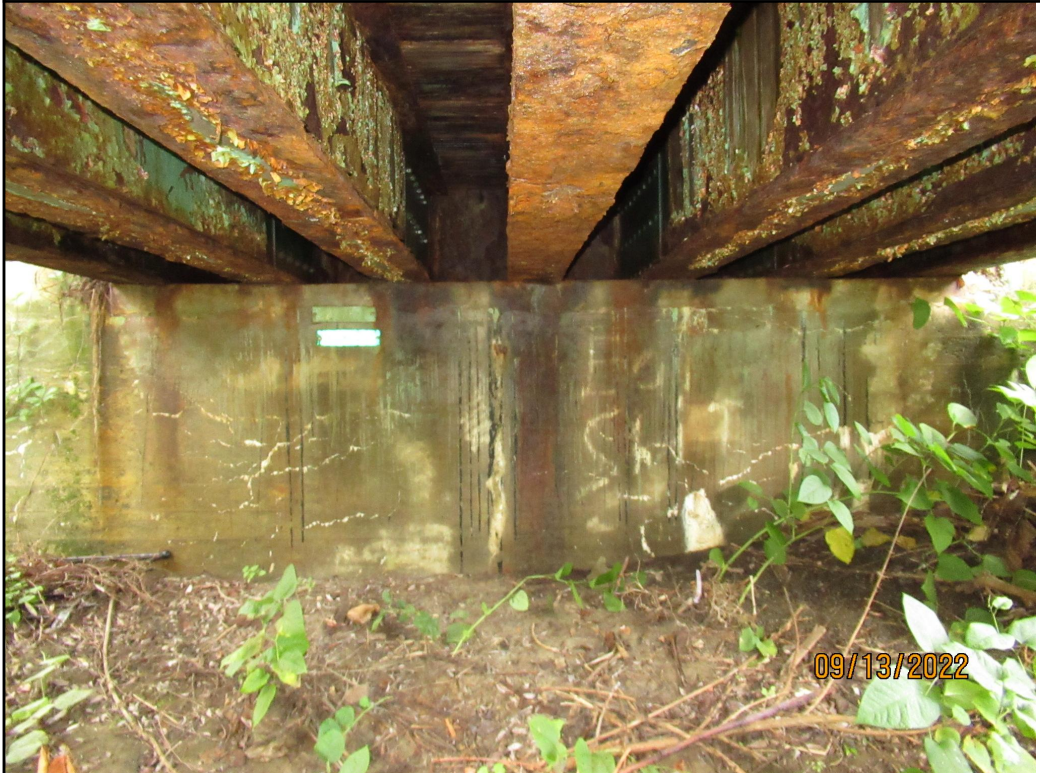
Photo Number: 13

**Attachment Description:**  
Looking back from midspan

Approximately half the length of the begin stem and wingwalls have map cracking with moderate efflorescence and scattered hollow sounding areas (photo 13). The right wingwall portion of the abutment has a 1 foot long 16 inch high spall by 2 inch deep spall on the top and front face (photo 14). The inboard face of the left cheek wall has a 2 square foot spall up to 2 inches deep (photo 15). Rate 21 feet CS3.

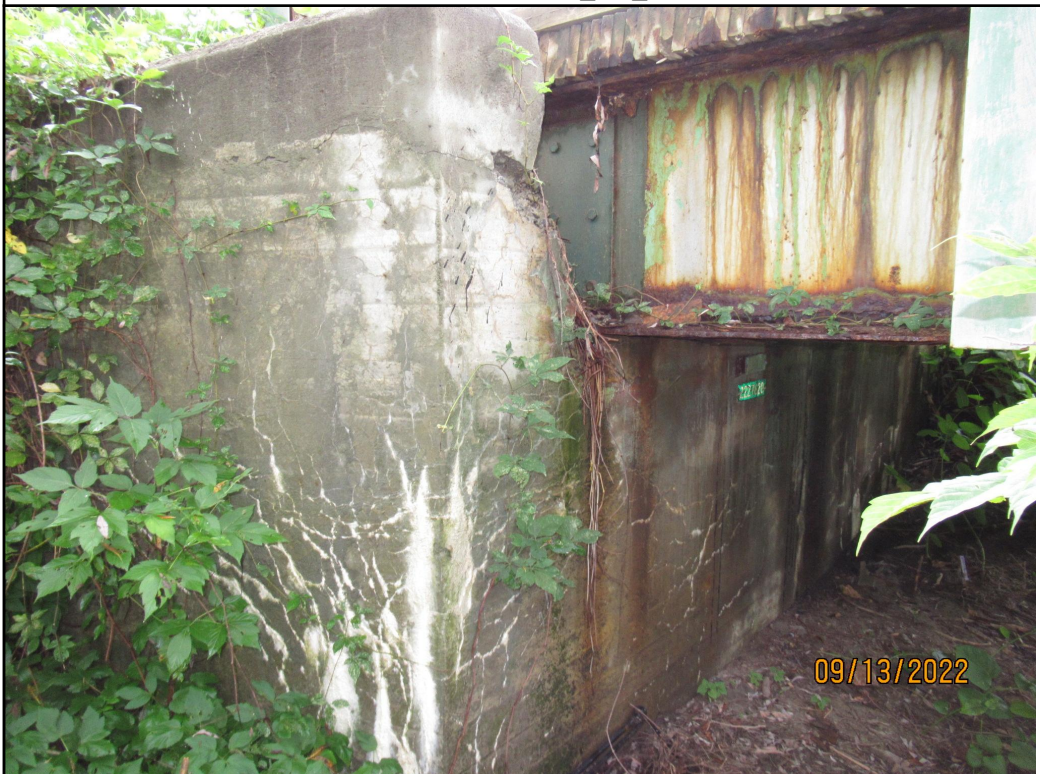
Photo Number: 14

**Attachment Description:**  
Begin abutment, right side  
looking left

Waterway – the existing bridge is currently listed as a scour critical due to the substructures being founded on soil. The begin abutment infringes on the hydraulic opening and has a history of scour.

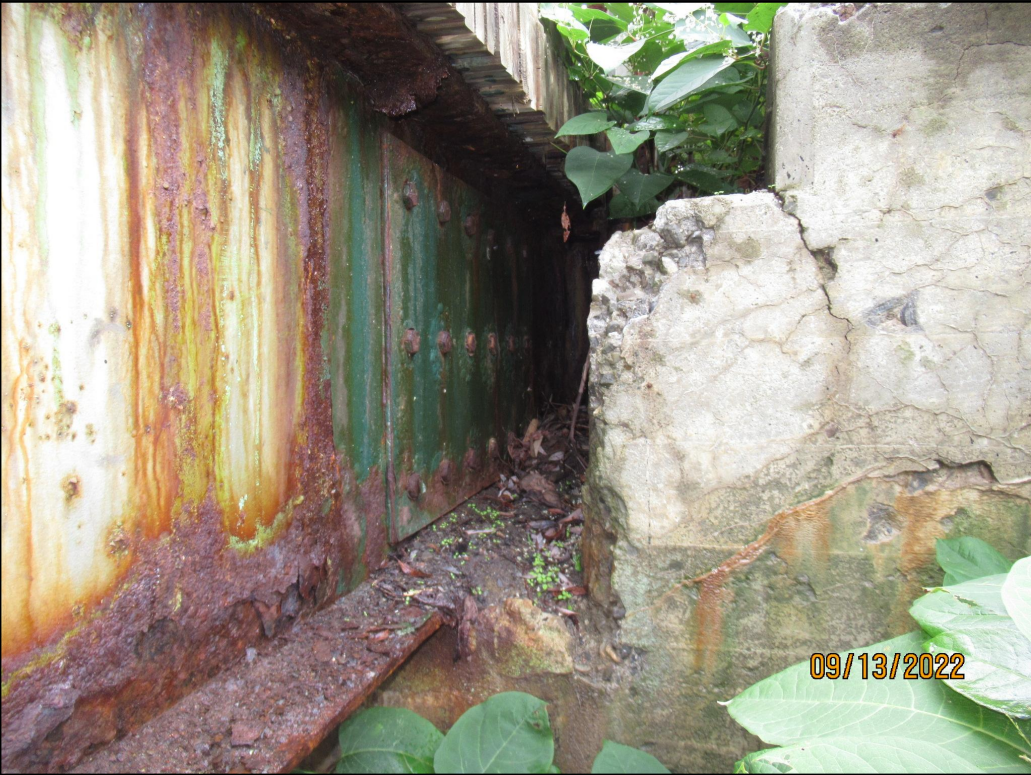
| <b>Attachment Description:</b><br>Begin abutment Left side<br>looking back | Photo Number: 15 | Photo Filename: 22_EH_0608.JPG |

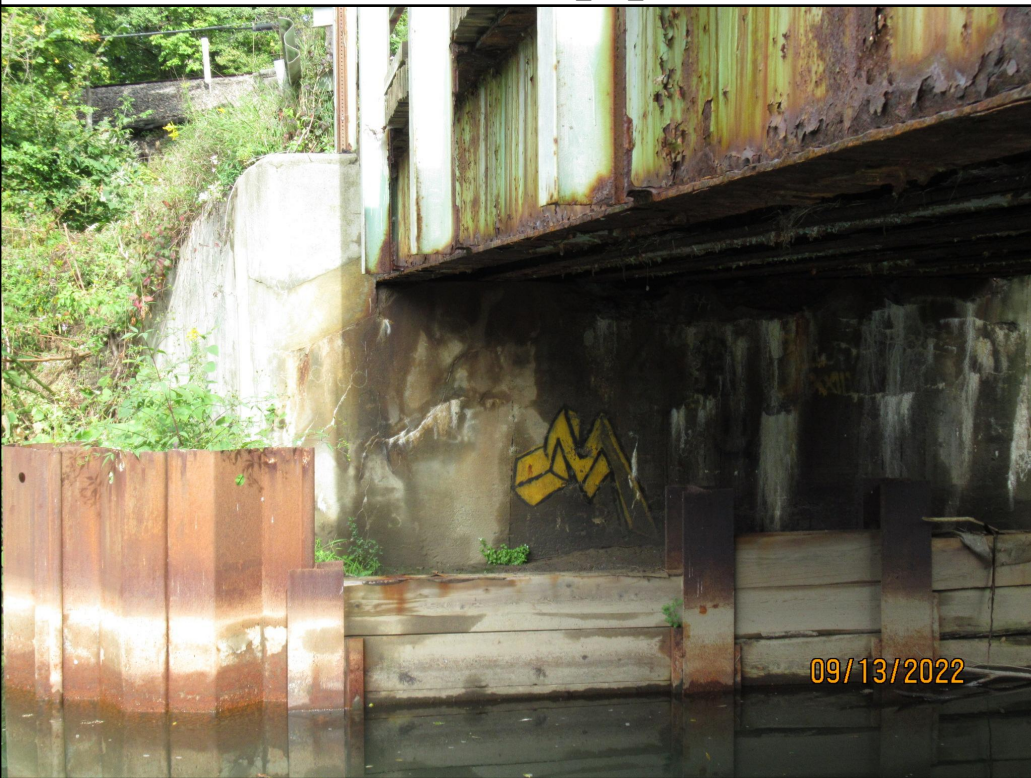
| <b>Attachment Description:</b><br>End abutment left side<br>looking ahead | Photo Number: 16 | Photo Filename: 22_EH_0599.JPG |

The end abutment stem and left side wingwall portion have map cracking with moderate efflorescence and scattered hollow sounding areas (photos 16). The top of the end abutment stem is spalled 1 foot long by 8 inches high and up to 2.5 inches deep below G1. Below girders G3 to G7, the shotcrete coating is spalled 10.5 feet long by 1 foot high and up to 4 inches deep with exposed and corroded welded wire mesh (photo 17). Rate 25 feet CS3.

| | TQ | CS-1 | CS-2 | CS-3 | CS-4 | CS-5 |
|---|---|---|---|---|---|---|
| The G1 pedestal is spalled 1 foot long by 8 inches high and up to 2.5 inches deep (photo 16). The G3 to G7 pedestals are spalled 1 foot high and up to 4 inches deep with exposed and corroded welded wire mesh (photo 17 and 31). The outside face of pedestals for girders G1 and G7 have up to 6 inches of wet debris covering the bearings and pedestals, similar to the begin abutment (photo 32). Rate 5 pedestals CS3. | | | | | | |

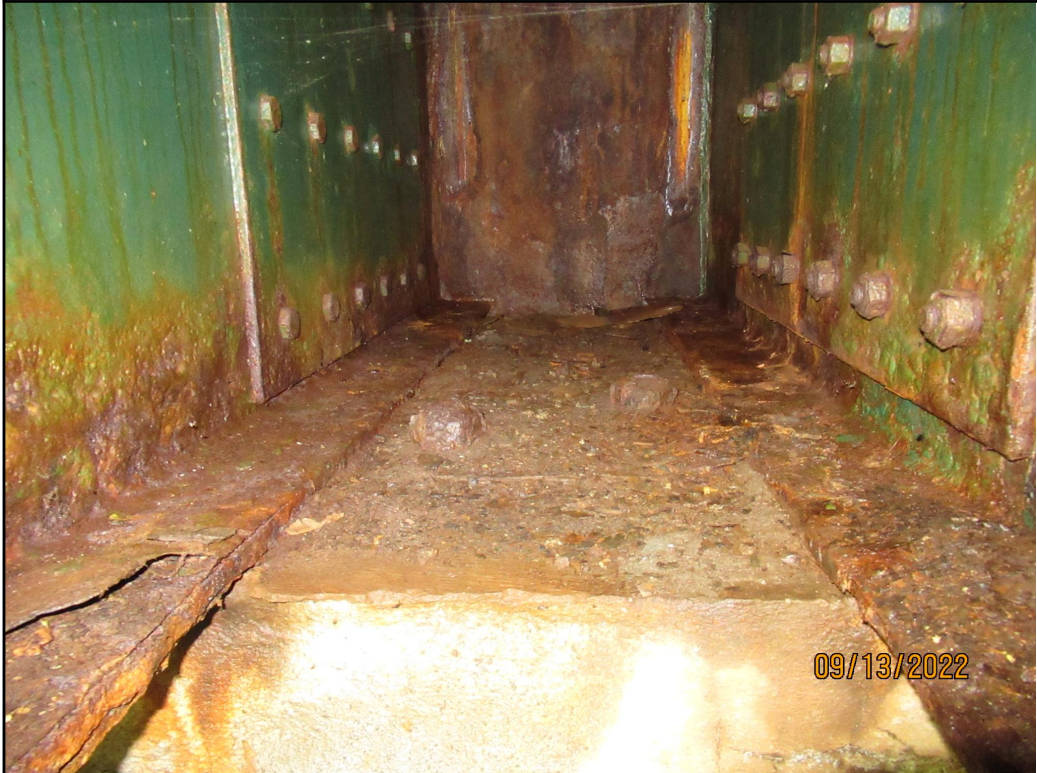
Photo Number: 19

**Attachment Description:**  
Begin abutment, bay 1  
looking back

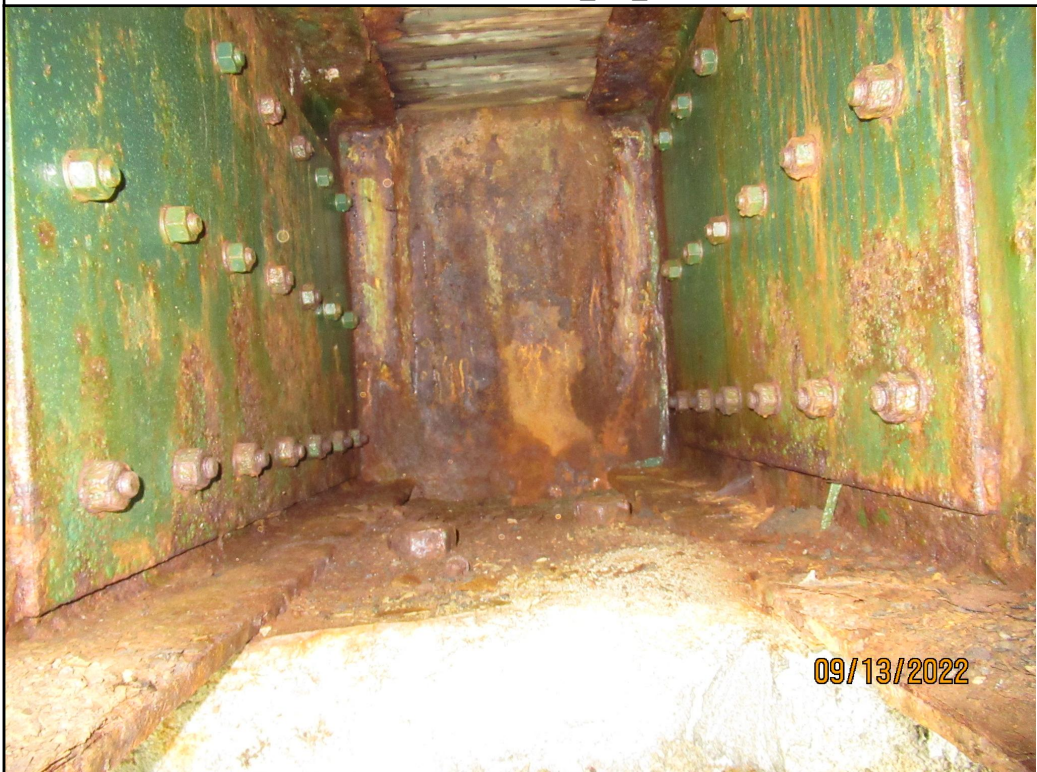
**Attachment Description:**  
End abutment, bay 6  
looking ahead

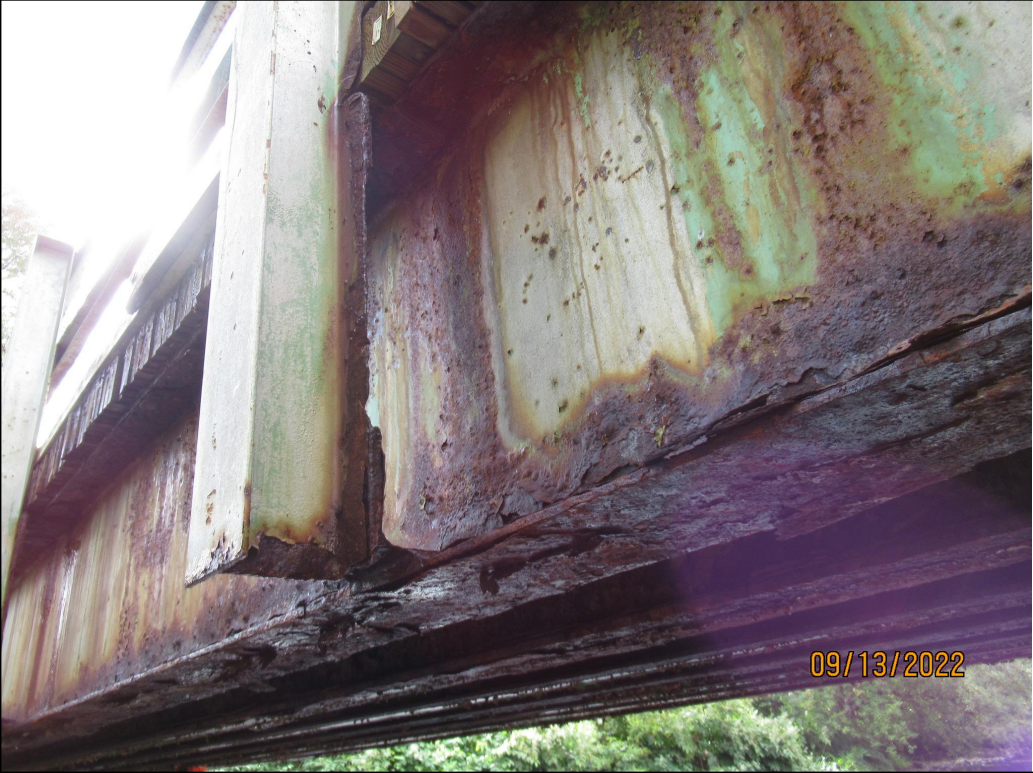
| <p><b>Attachment Description:</b><br/>Right side post 9 looking back</p> | Photo Number: 21 | Photo Filename: 22_EH_0619.JPG |

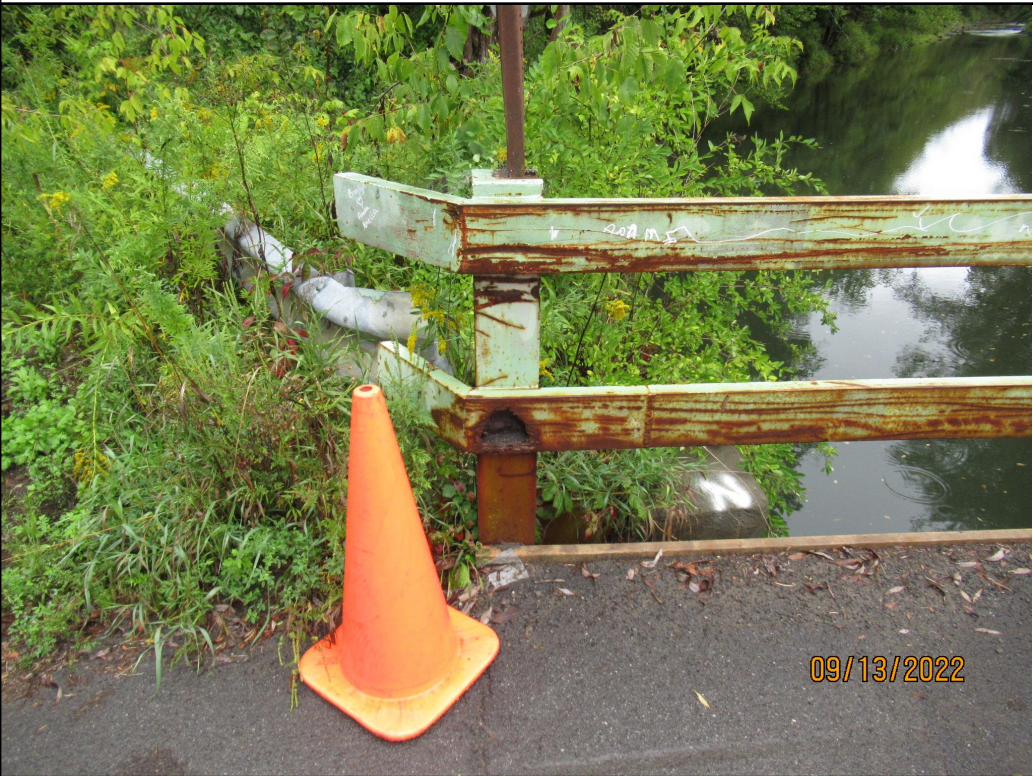
| <p><b>Attachment Description:</b><br/>End right corner looking right</p> | Photo Number: 22 | Photo Filename: 22_EH_0625.JPG |

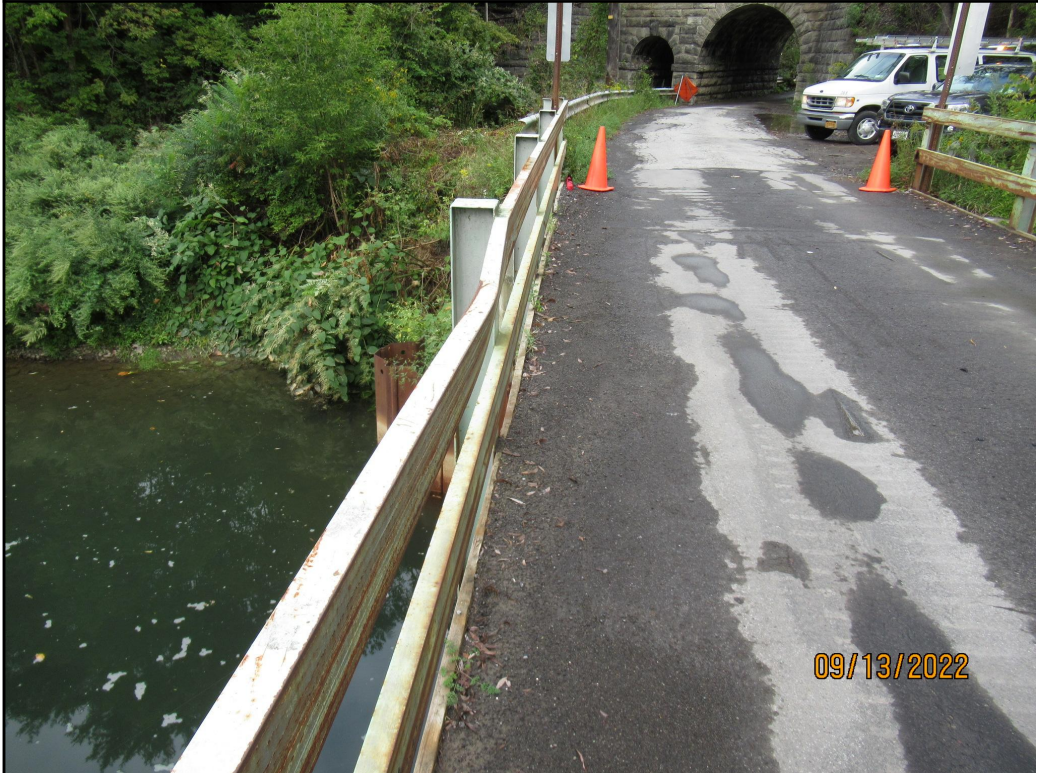
Photo Number: 23

**Attachment Description:**  
Left side looking ahead

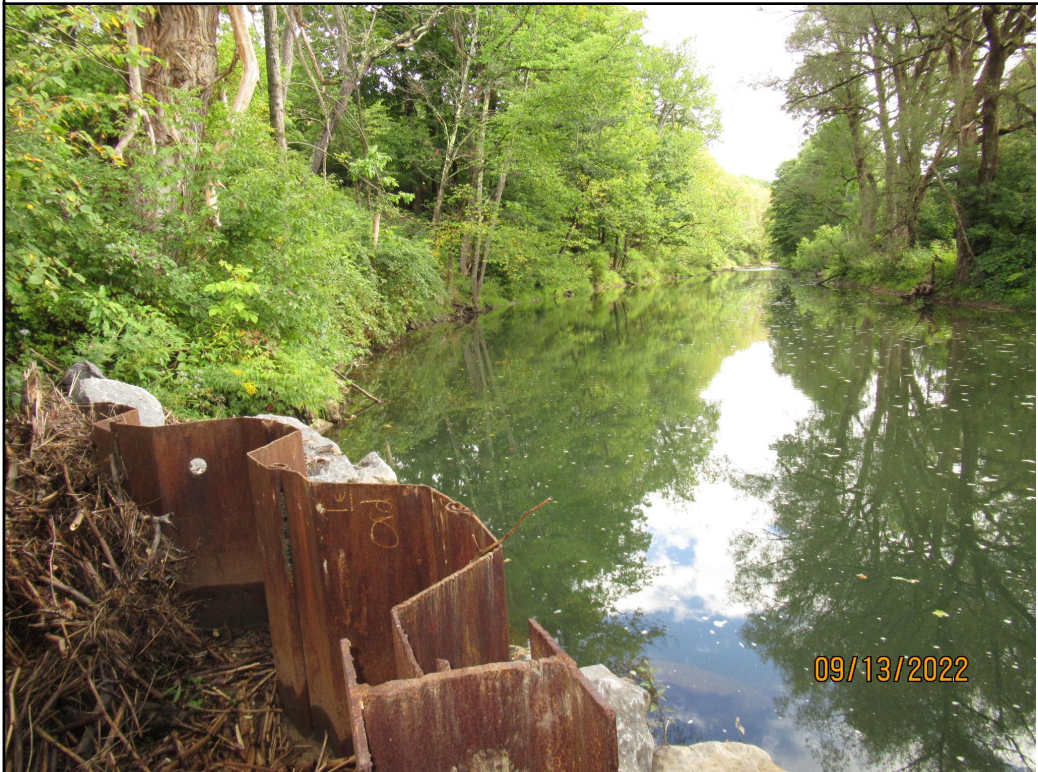
Photo Number: 24

**Attachment Description:**  
Looking right from end  
abutment

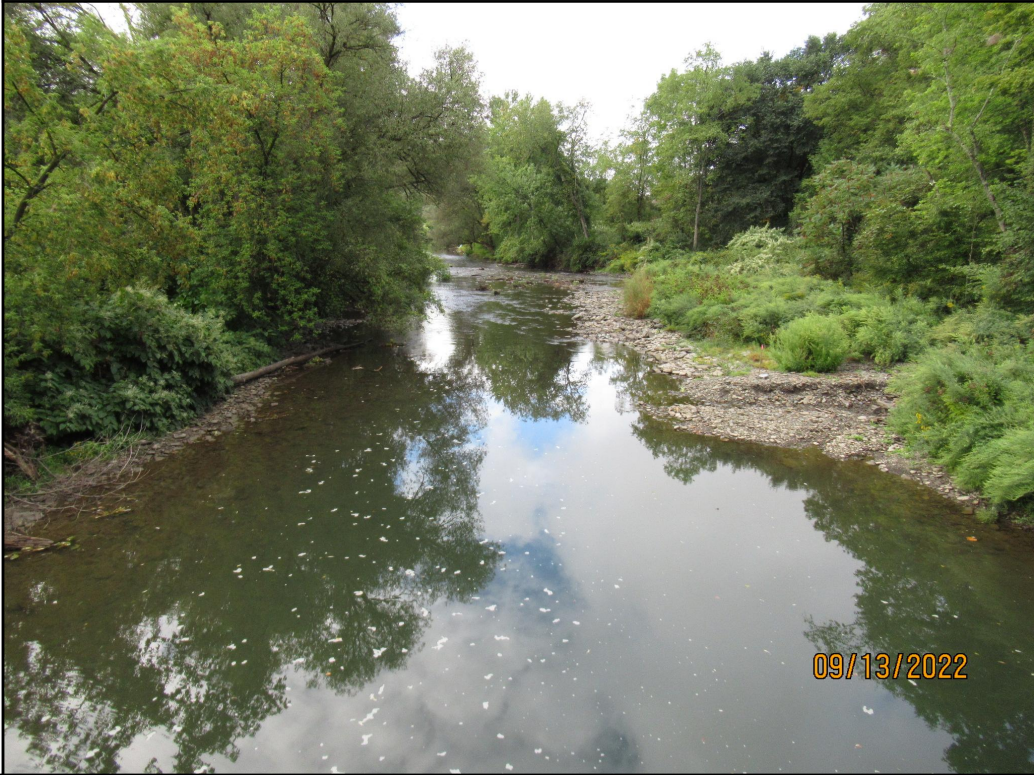
| <p><b>Attachment Description:</b><br/>Looking left, downstream</p> | <div>Photo Number: 27      Photo Filename: 22_EH_0591.JPG</div> |

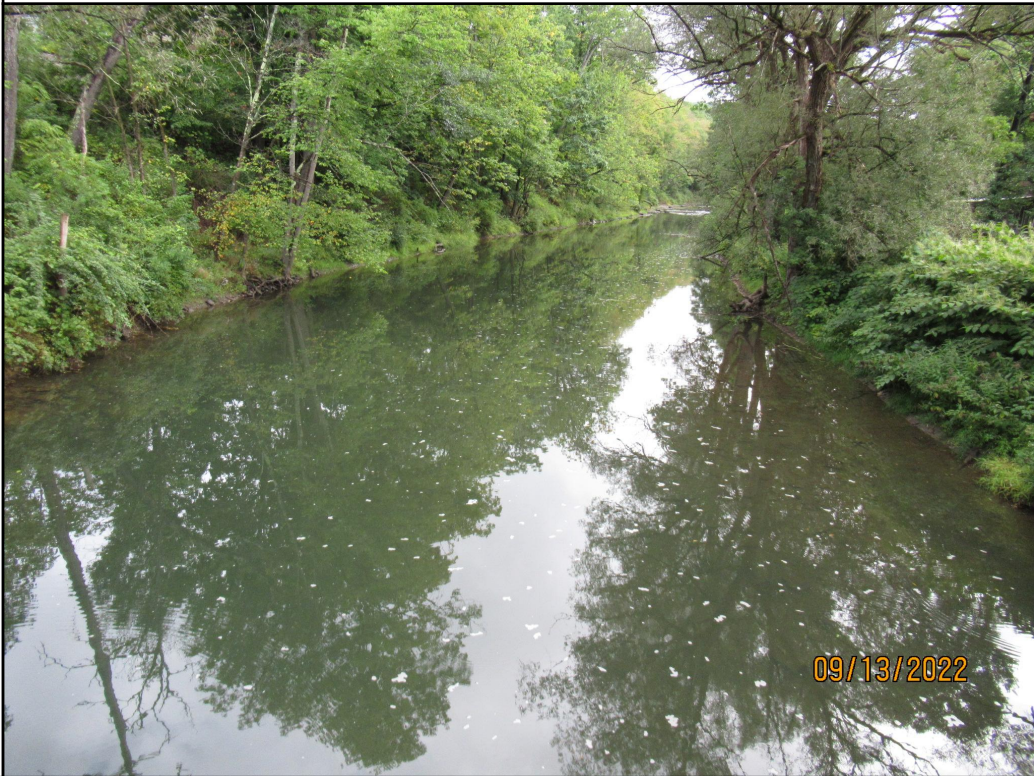
| <p><b>Attachment Description:</b><br/>Looking right, upstream</p> | <div>Photo Number: 28      Photo Filename: 22_EH_0592.JPG</div> |

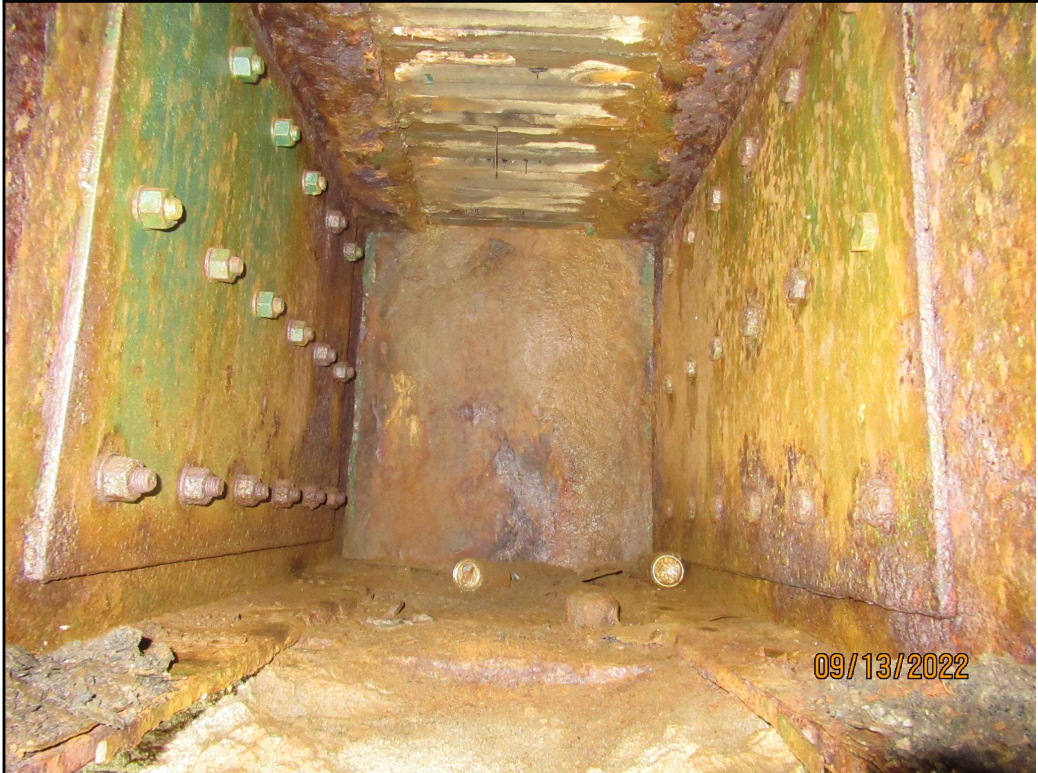
Photo Number: 30

**Attachment Description:**  
Begin abutment at G7  
looking back

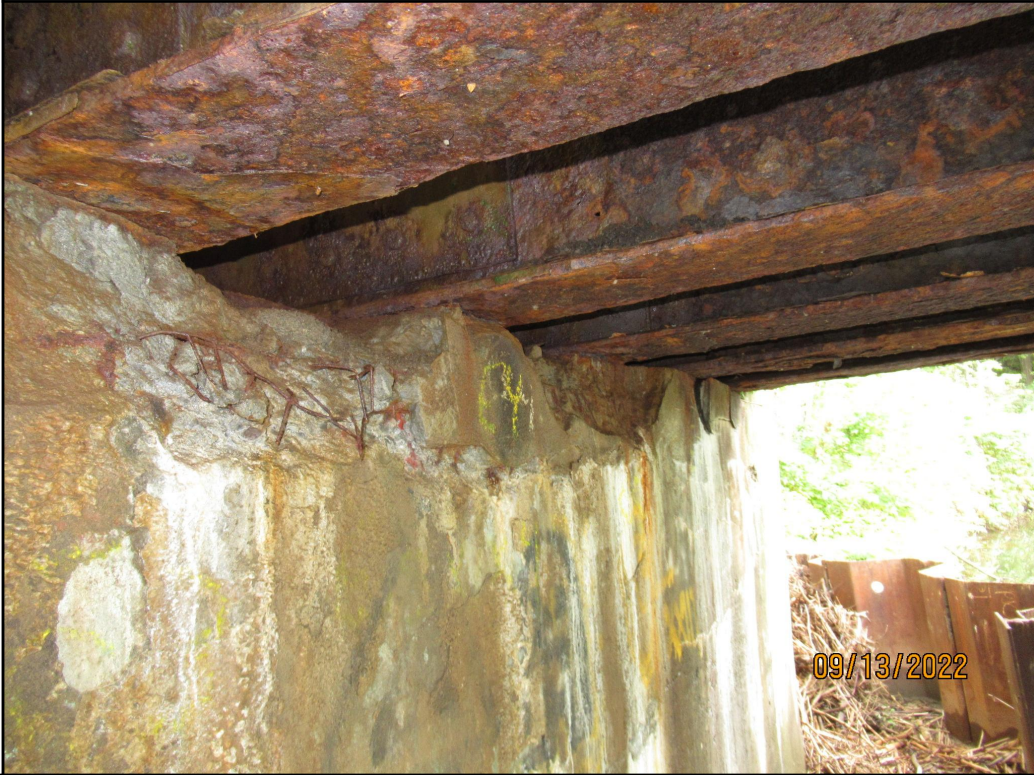
| <p><b>Attachment Description:</b><br/>End abutment, G3 to G7<br/>looking right</p> | <div>Photo Number: 31      Photo Filename: 22_EH_0615.JPG</div> |

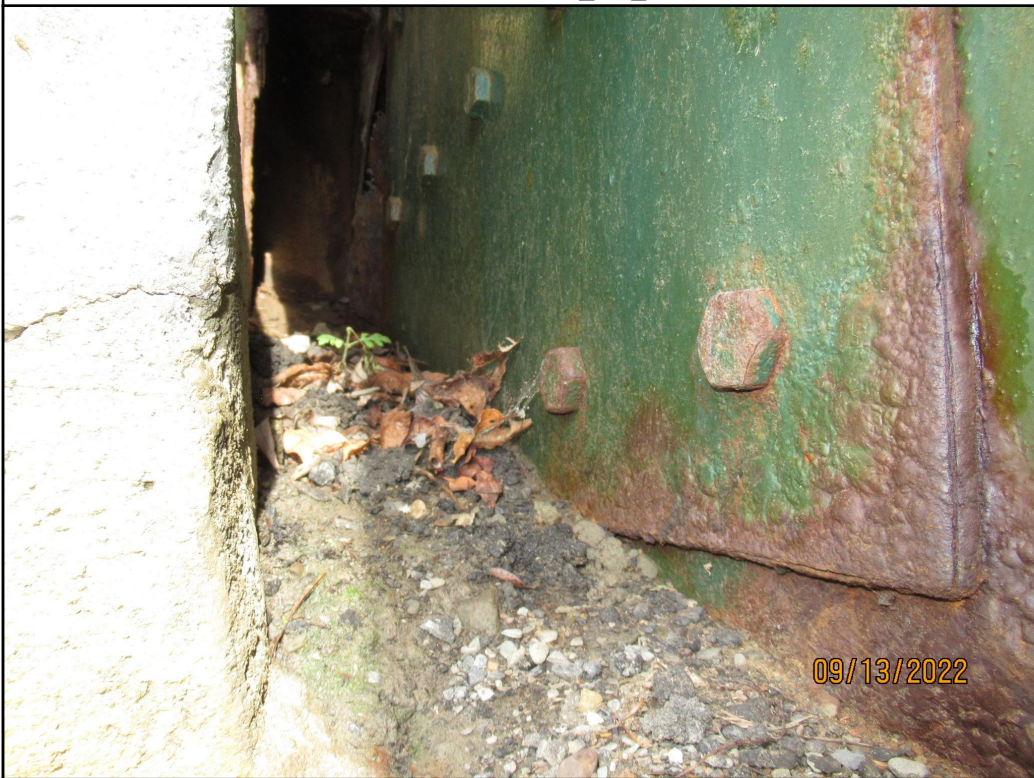
| <p><b>Attachment Description:</b><br/>End abutment, G1 looking<br/>ahead</p> | <div>Photo Number: 32      Photo Filename: 22_EH_0616.JPG</div> |
