# Transportation Project Report

## Draft Project Scoping Report/Final Design Report

Loft Rd over Schenevus Creek (BridgeNY 2021) Bridge Replacement  
Project Identification Number (PIN): 9755.19  
Bridge Identification Number (BIN): 2227620  
Town of Maryland  
Otsego County

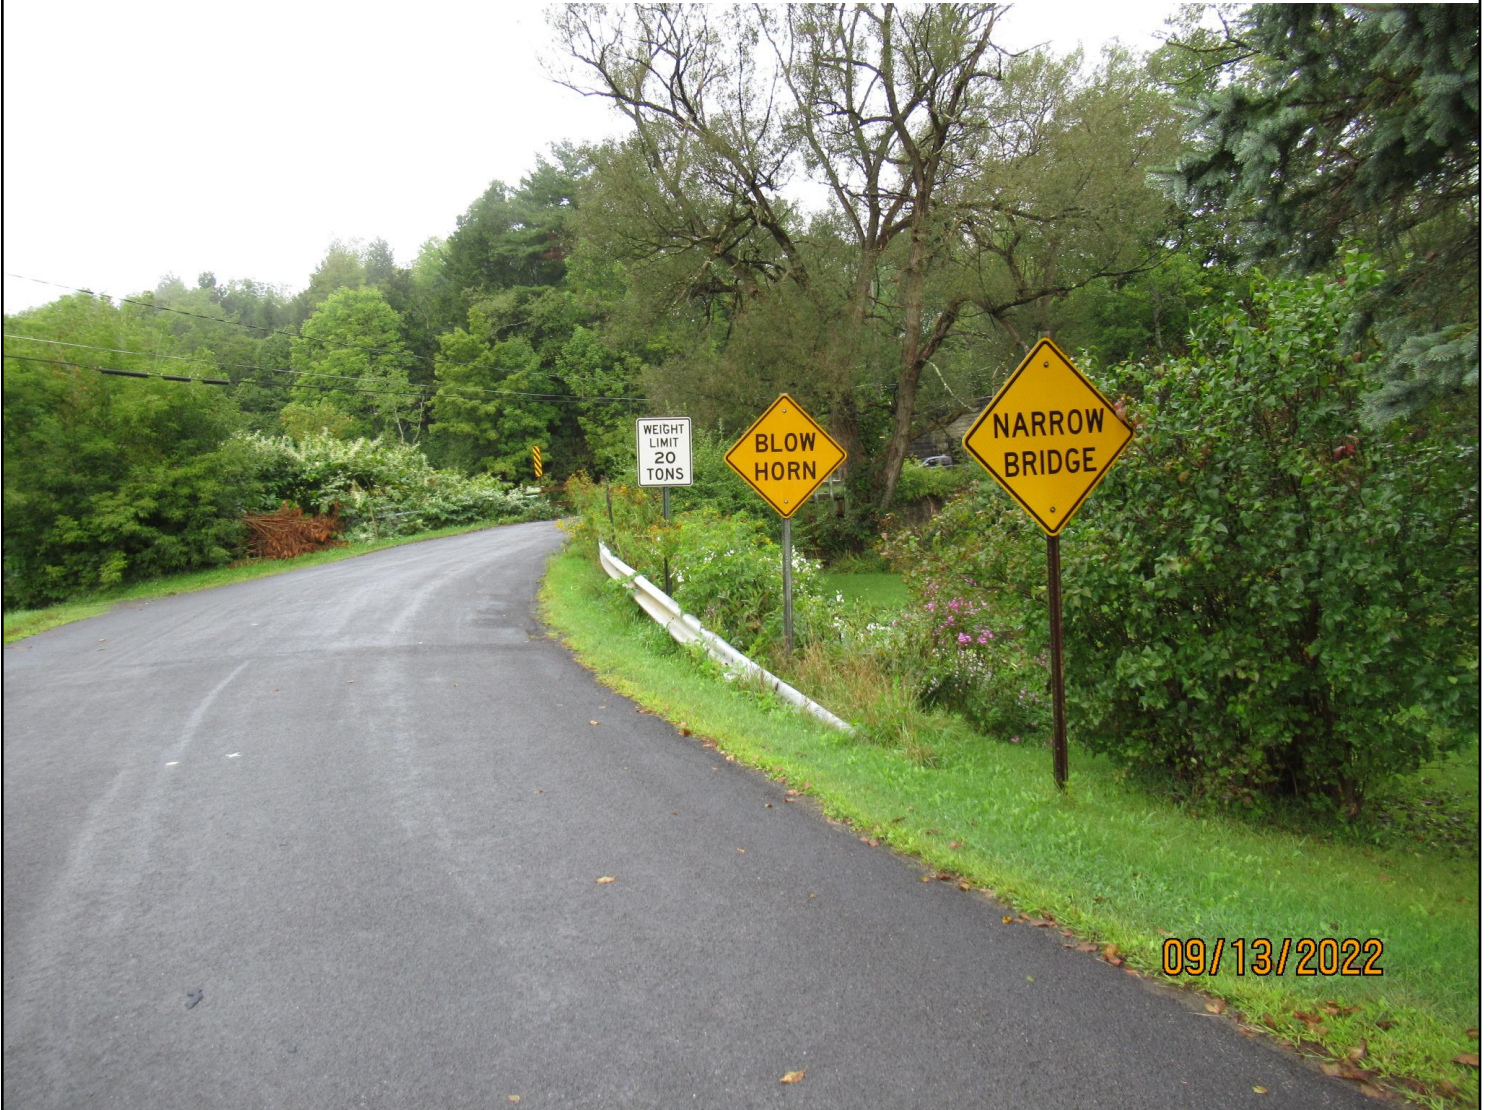
Photo Number: 1

**Attachment Description: Begin approach looking ahead**

No changes are proposed to any of the existing driveways within the project limits. Adjacent to the bridge, the Norfolk Southern railroad arch bridge over Loft Road causes conflict due to limited sight distance. Improvements to the sight distance through the railroad arch bridge are included in the proposed condition.

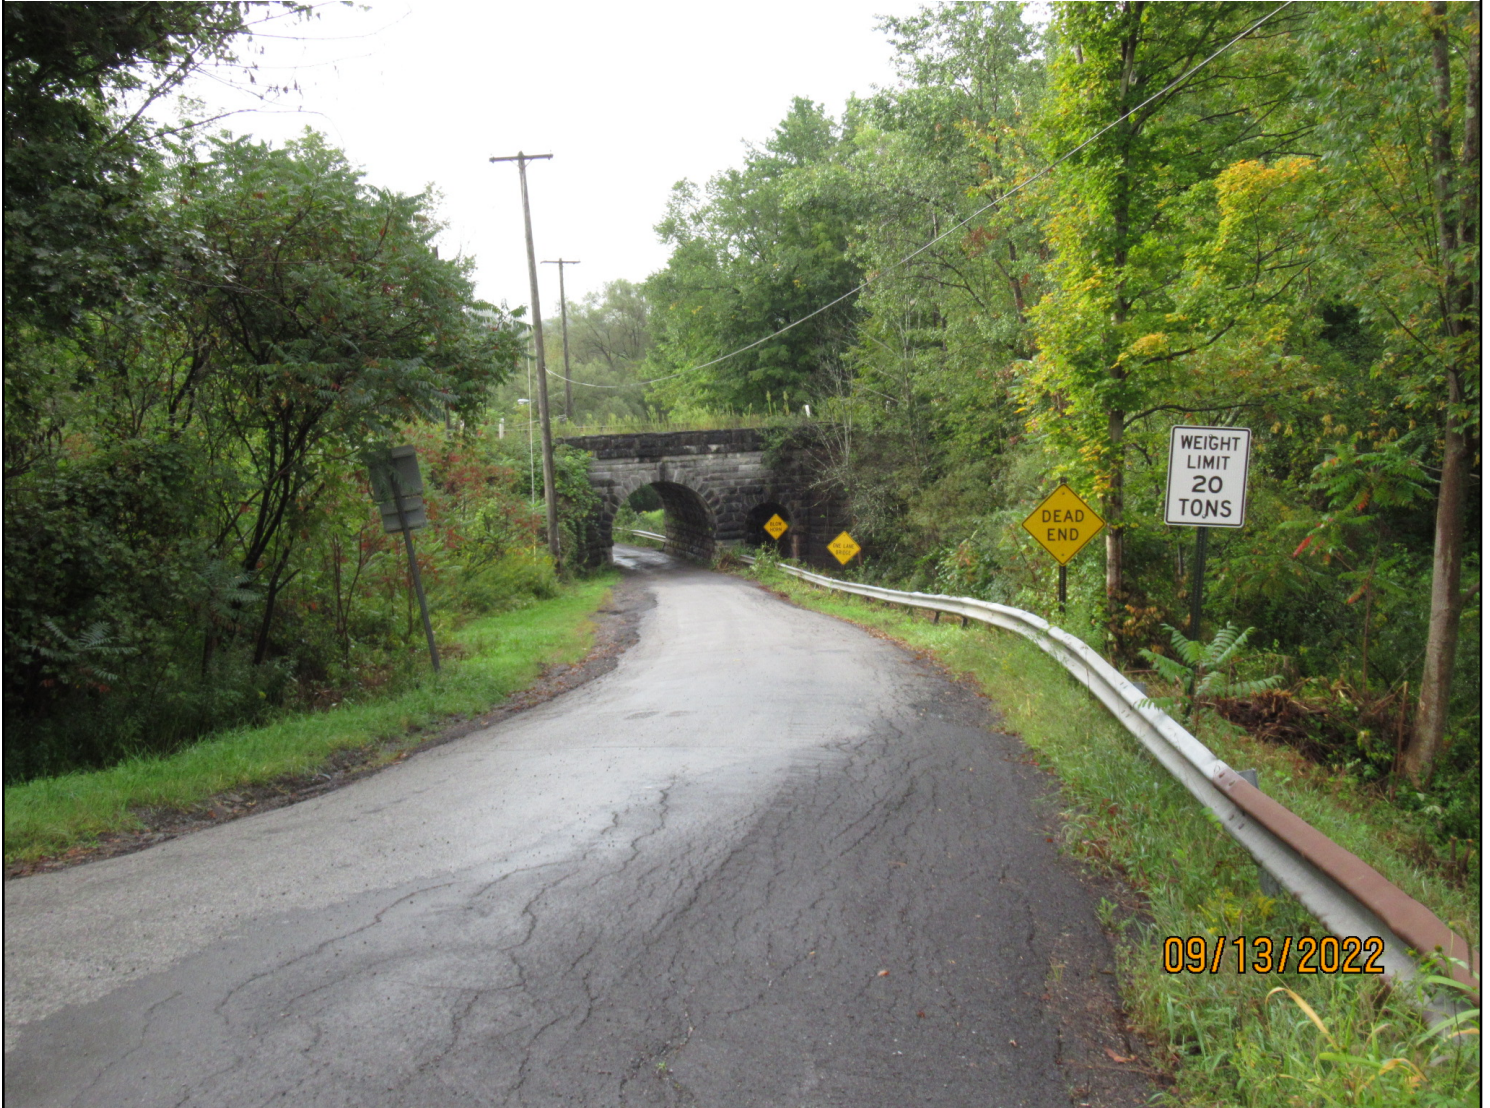
Photo Number: 2

***Attachment Description: End approach looking back***

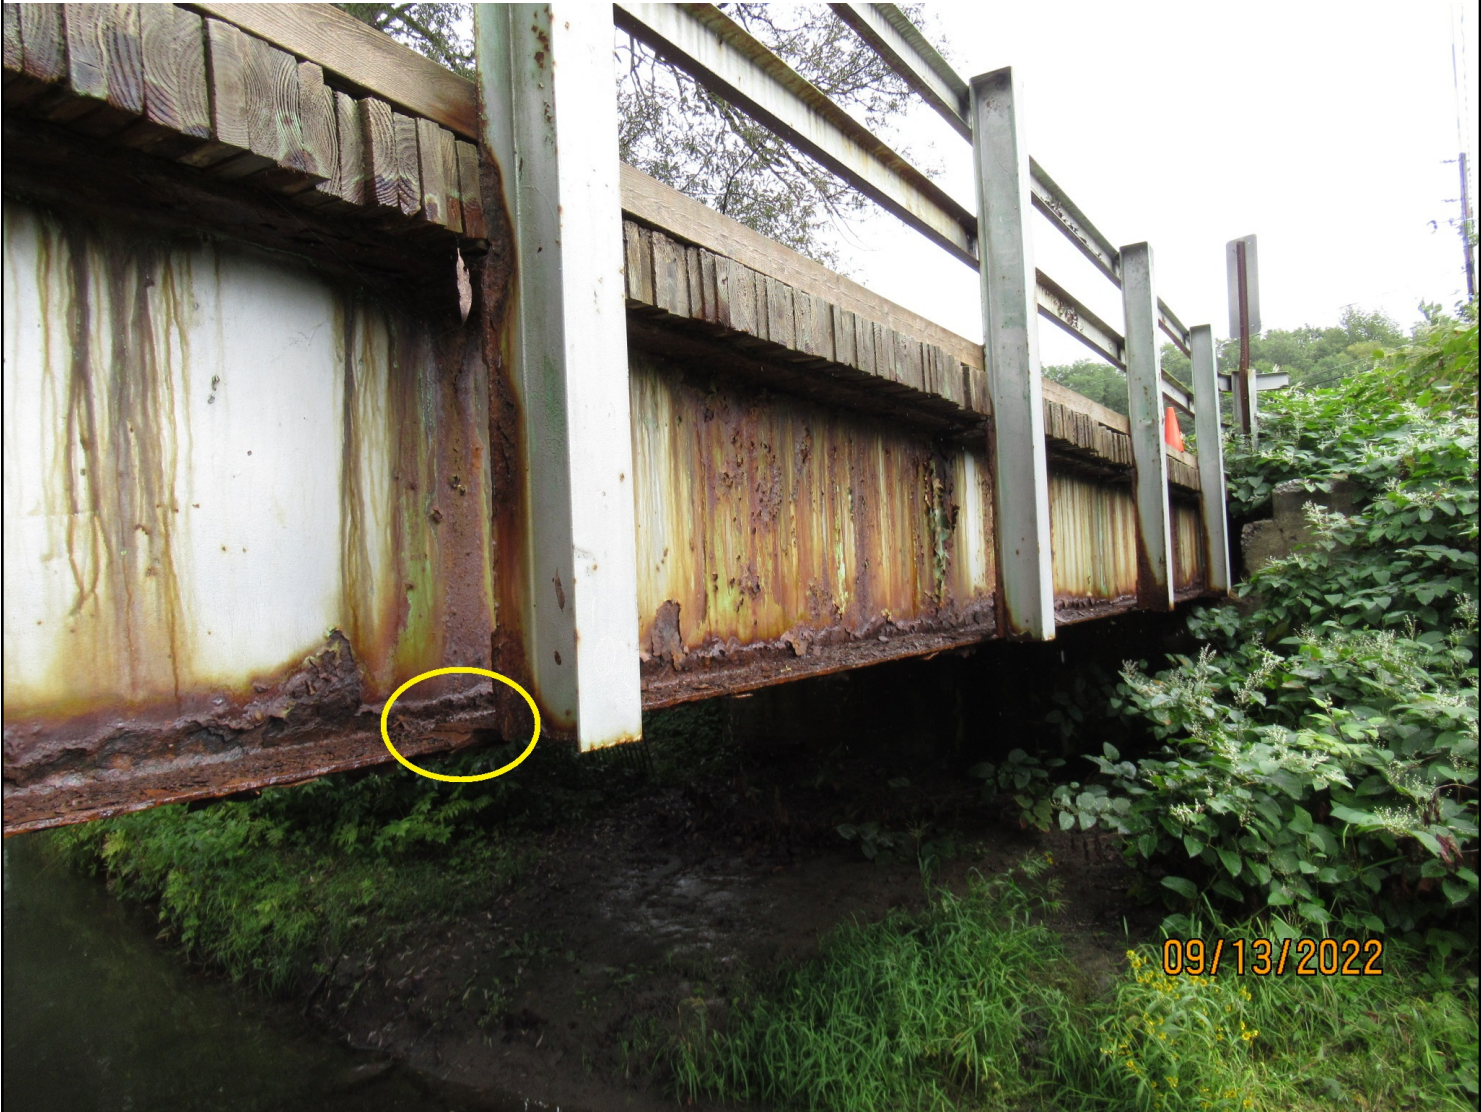
Photo Number: 1

**Attachment Description: Left side looking back**

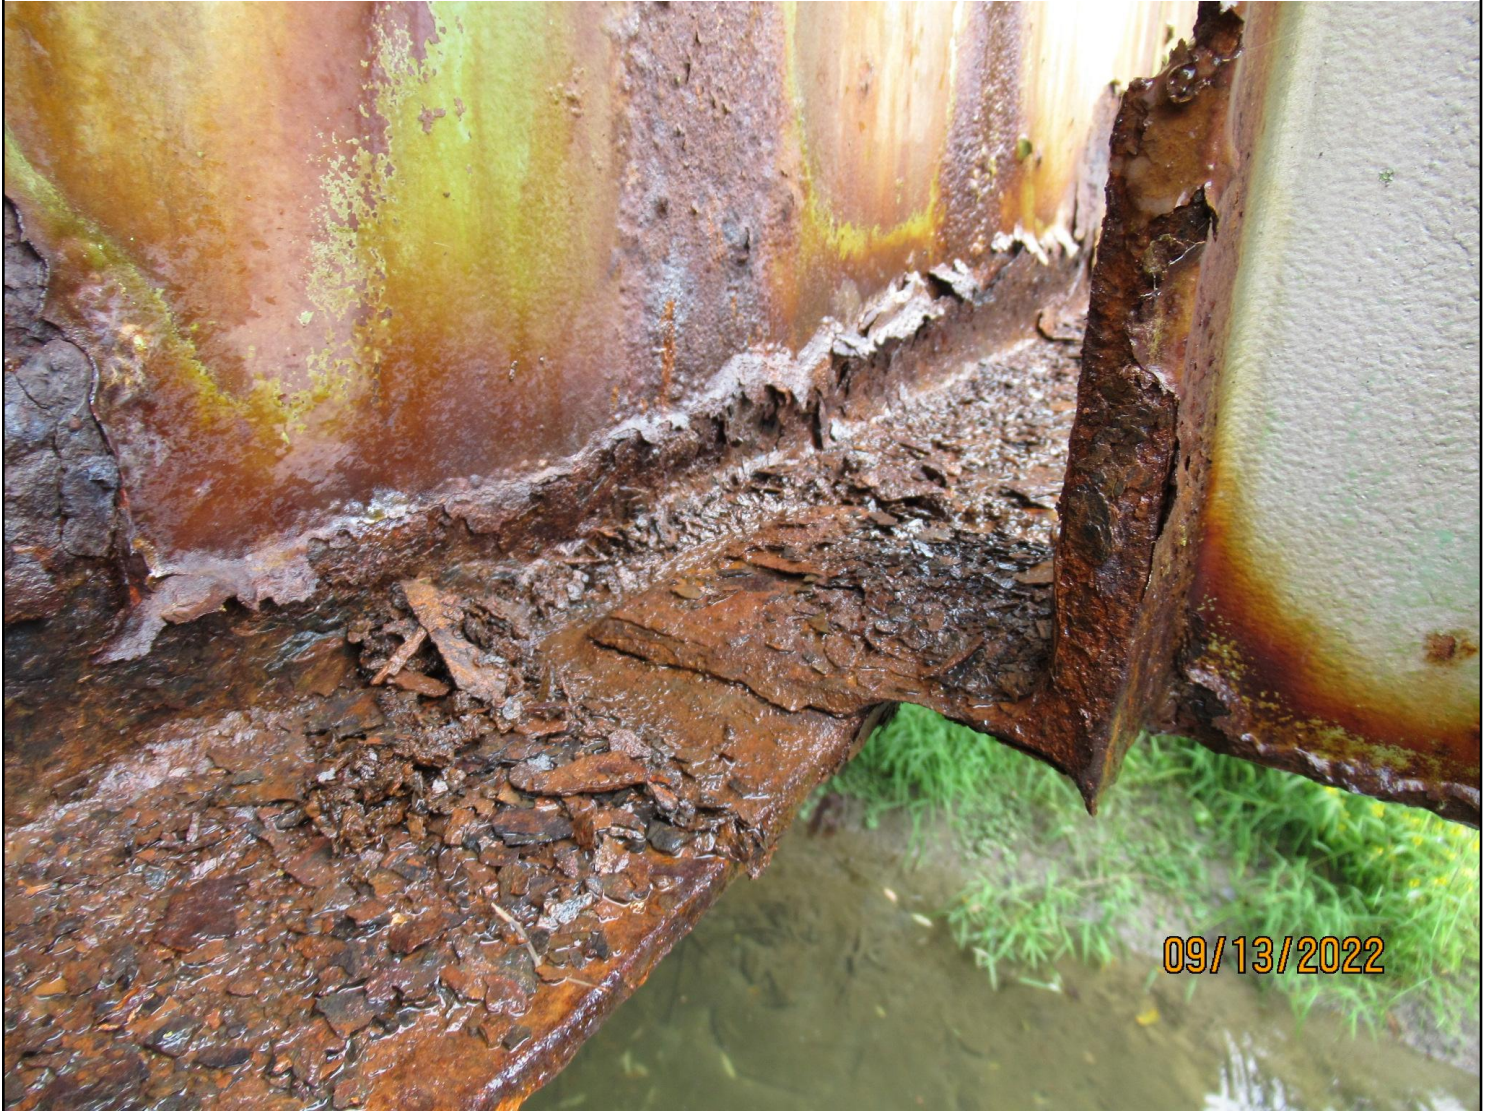
Photo Number: 2

**Attachment Description:** Left side, post 4 looking back

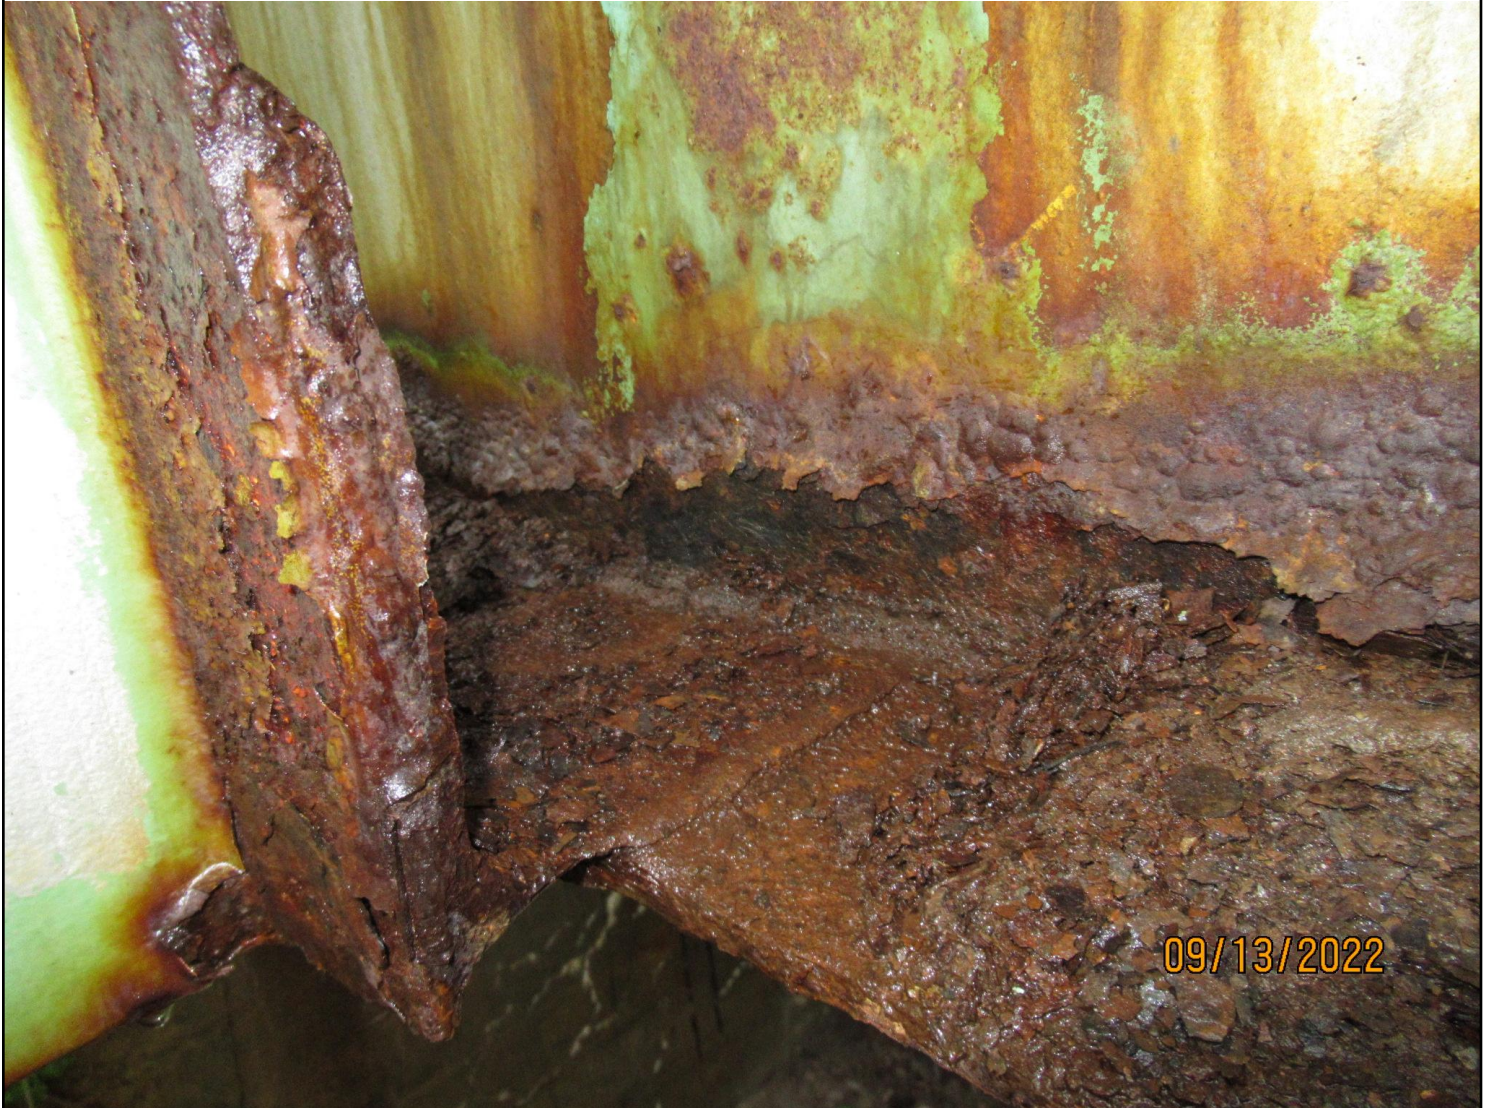
Photo Number: 3

Right side, post 1: The weld is cracked on all sides but the connection is firm and may not be cracked thru. (photo 3)

The cracks have the potential to propagate into the base metal of the steel beam.

***Attachment Description: Right side, post 1 looking back***
